17 Ganavan Bay

17.1 Background Information

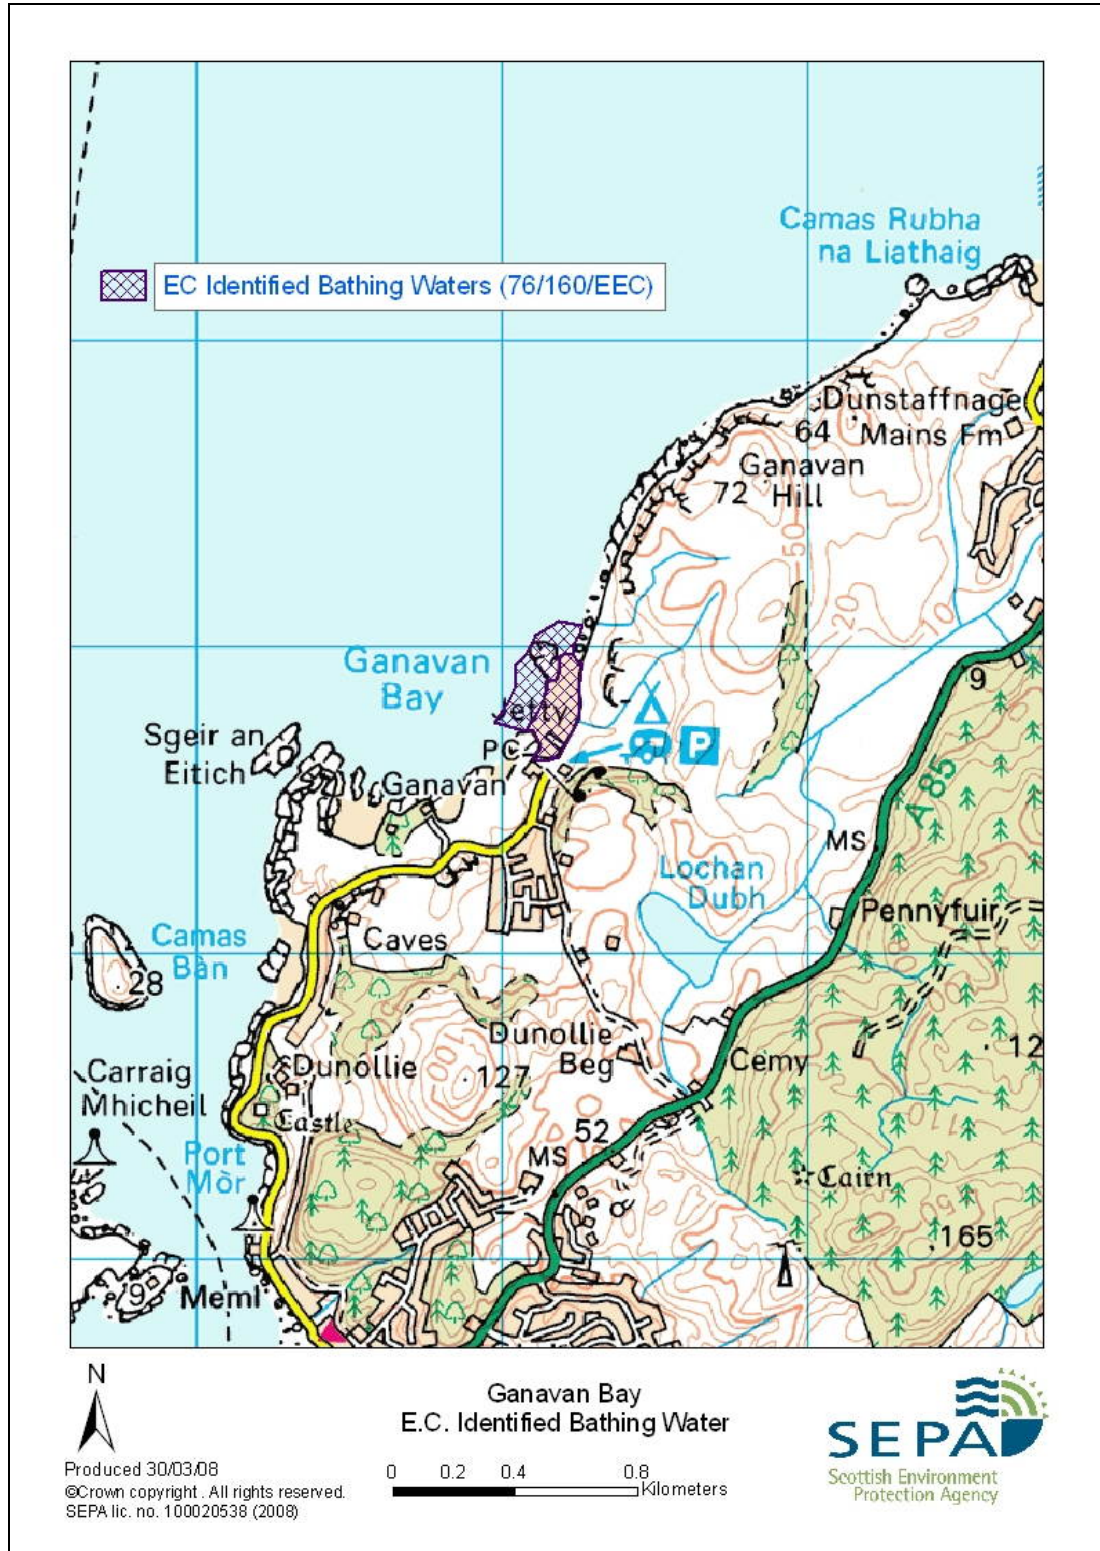
Figure 17A: Map of the Ganavan Bay designated bathing beach and surrounding local area.
