27 Fraserburgh (Philorth)

27.1 Background Information

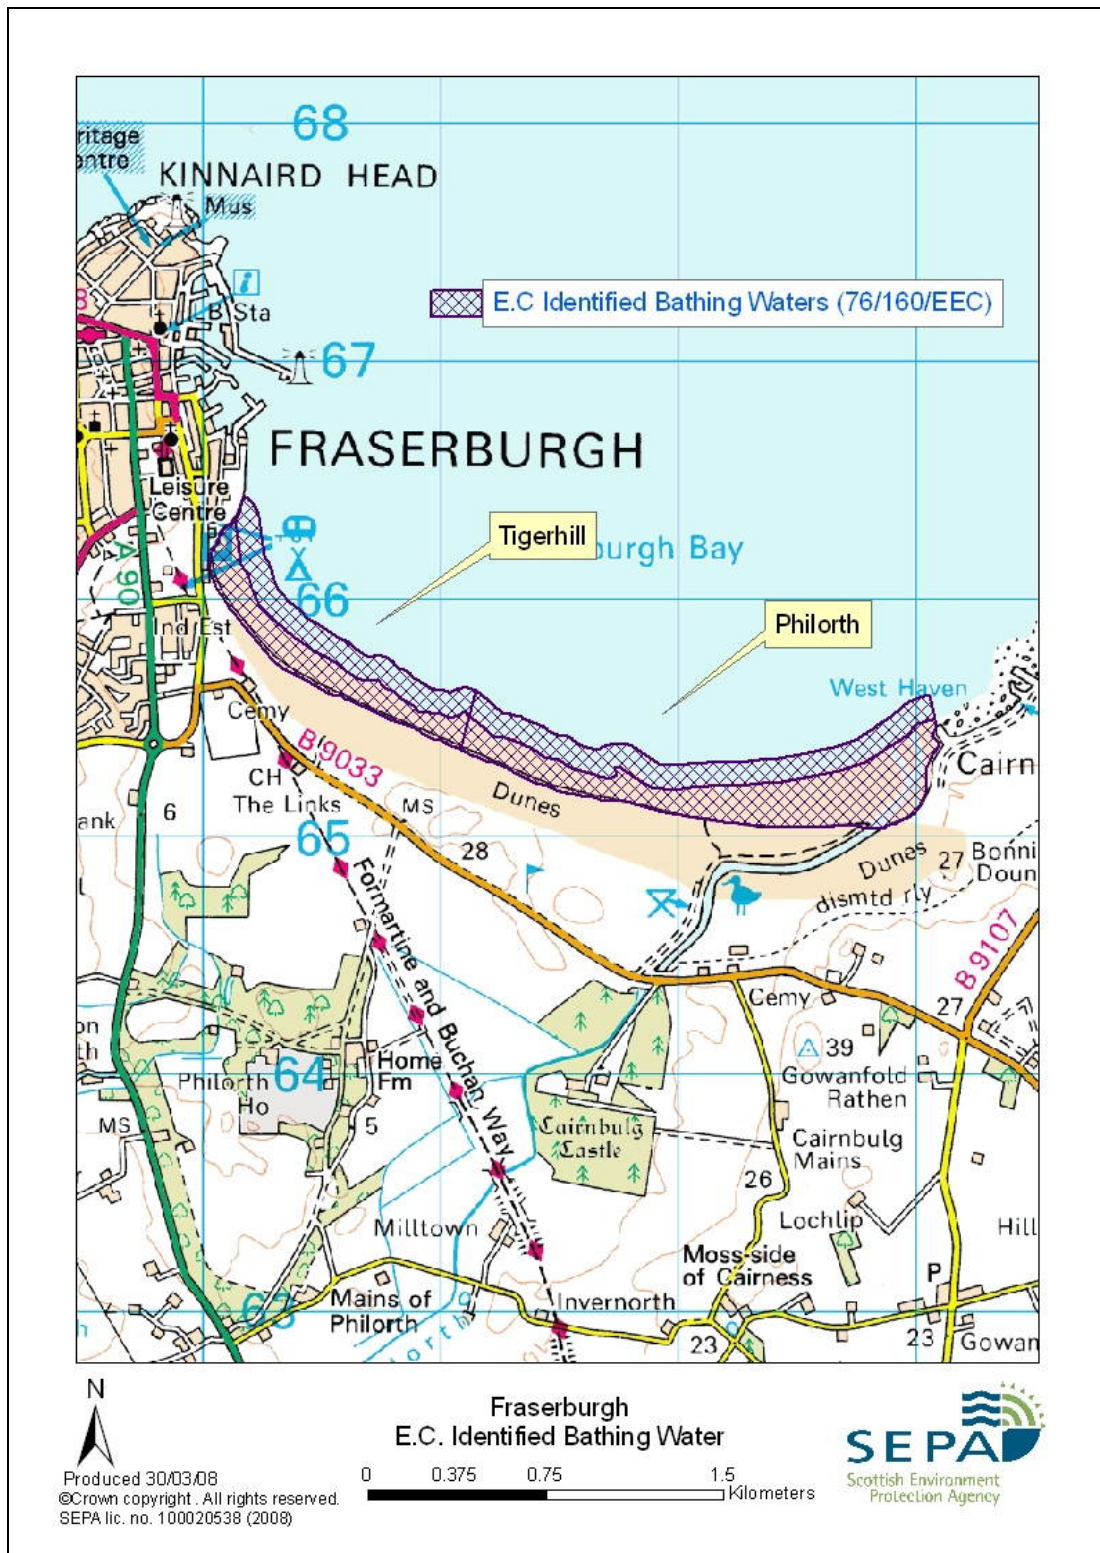
Figure 27A: Map of Fraserburgh (Philorth) designated bathing beach and surrounding local area.

The Fraserburgh (Philorth) EC identified bathing water is adjacent to Fraserburgh (Tiger Hill) bathing water, and makes up the other half of Fraserburgh Bay (Fig. 27A). It is an extensive, pristine sandy beach with an extensive sand dune system and lies adjacent to the waters of Philorth Local Nature Reserve. Philorth is a popular recreational, surfing and windsurfing area and also favoured by families.

There are no sewage discharges in the immediate vicinity of the bathing water. The only watercourse feeding to this bathing water is the Water of Philorth which discharges some distance to the east of the monitoring point.
